HAZARD ALERT

Failures of a Pressure – Sensitive Safety Mat Results in a Fatality

> Preliminary Report

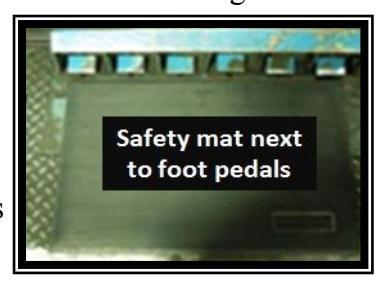
An hourly production tire-builder died one week after he sustained serious injuries from being caught-in a modified "Super 90" Tire Assembly Machine (TAM). The worker was found unconscious between the tire-building drum and the pneumatic "innerliner/now" server trays with a hand-stitcher in his left hand. Post-incident, the TAM was tested in various modes and operations to recreate the incident. During these tests, it became obvious the safety mat failed to work correctly. The mat is intended to prevent movement of the server trays when a worker is standing on the mat. The front half of the mat (closest to the TAM's foot pedals) failed to sense the presence of a worker, especially in the upper left front quadrant. The rear half of the mat functioned properly and stopped the server trays from moving forward to the building drum. The mat is approximately 30"x19½". Research and information gathering continues to seek the manufacturer's name, model/serial number and date of manufacture. The mat was neither anchored to the floor, nor sufficient in size to protect workers. There was no visual means such as red and green in-

dicator lights to indicate whether the mat was detecting the presence of a worker. This made it impossible for workers to know if it was operating properly. State OSHA also said the mat was not adequate because, "there was no safety interface controller/safety interface module (failsafe) installed with the mat that would prevent the machine from working if there was a problem/failure with the mat."

- Where safety mats are present, they must be installed, used, maintained per the manufacturer's recommendations and ANSI B11.19. This includes such things as; anchoring, size of the safety mat(s) and the calculation of the safety distance so that the effective sensing surface prevents individuals from reaching the hazards during the hazardous portion of the machine cycle, a safety interface controller/safety interface module (failsafe) to monitor for open circuits or physical damage, visible red/green indicator lights to indicate the safety mat is detecting the presence of individuals on its sensing surface, documented procedures/records are posted for periodic testing and inspections.

- In most instances, safety mats alone do not provide a degree of protection deemed necessary to meet the intent of OSHA's regulations. Therefore, redundant guarding is desirable and on occasion necessary to achieve reliable safeguarding of employees from hazardous machine components. The application of safety mats has generally been to provide such redundant safeguarding. Often safety mats are used in conjunction with light curtains. Light curtains are self checking and will shut down a machine if they fail.
