HAZARD ALERT

Fatal Incident Involving a Recovery Boiler and Salt Cake Engulfment at a Paper Mill

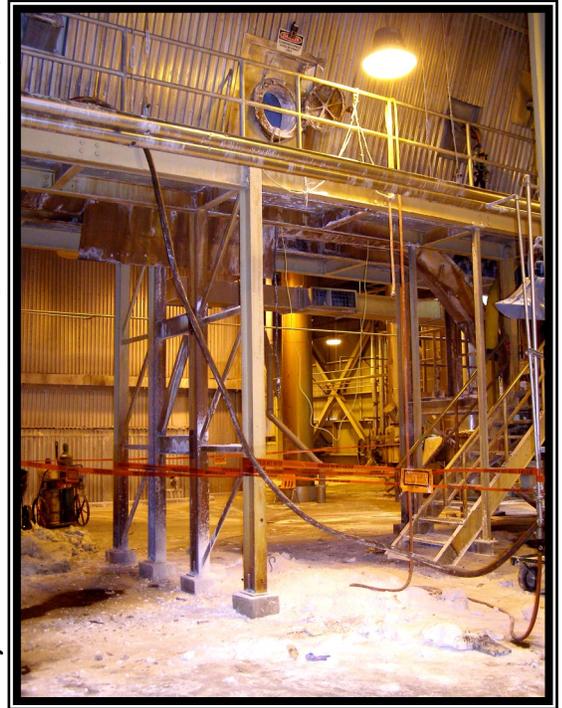
Two USW mechanics were attempting to replace a broken drag chain conveyor inside the economizer ash hopper of a recovery boiler on the third floor, when they were engulfed by falling salt cake approximately 40-50' above from the fifth floor. The recovery boiler had been down for three days due to a smelt (molten salt) leak. While the recovery boiler was water washed, some hard to reach areas of the economizer and associated outlet ductwork were not sufficiently cleaned. A contractor had been called in to clean out the salt cake around the drag chain. Unfortunately, one of the mechanics died as a result of the incident, the other was taken to an area hospital where he was treated and released, but will miss days of work.

- Identify all areas where salt cake can build up on tapered walls, in ductwork, etc. Working with the recovery boiler manufacturer, eliminate and/or control these areas with the hierarchy of controls.

- Work with the recovery boiler manufacture to have sufficient access doors available in the duct work and other hard to see/cleaning areas for maintenance and inspections.

- Explore options to prevent salt cake build up i.e. vibrators, blowers and air cannons.
- All employees must be task trained, provided with written procedures that calls for opening all access doors, on all floors, for inspection and complete water washing from the top floor down to the bottom floor, including outlet ductwork.

- Develop training materials, videos, photos, etc., to aid with hazard identification and controls needed for safe operation, servicing and maintenance of recovery boilers, including water washing inside all areas of the recovery boiler and problem areas.

- Install scaffolding where possible to provide overhead protection for work crews.
- Ensure a robust Permit-Required Confined Space program and procedures.
