# Safety Alert

## Fatality at Construction Site

### Pipe Liner Entangled in Winch

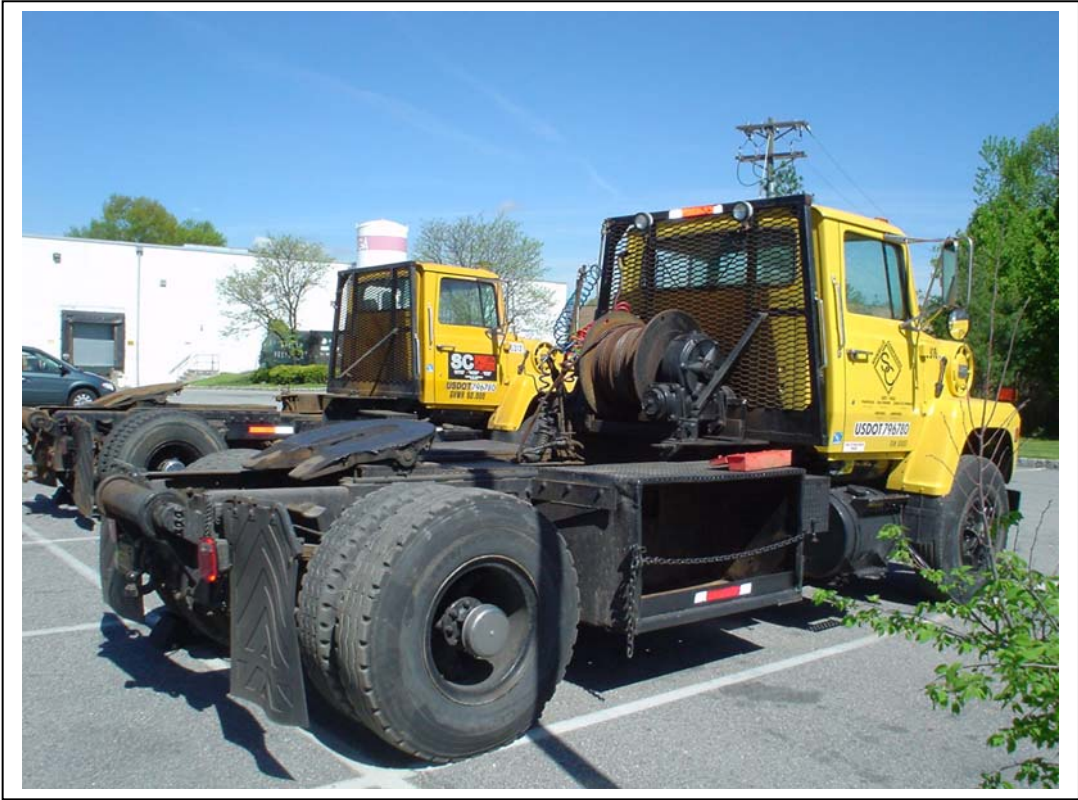
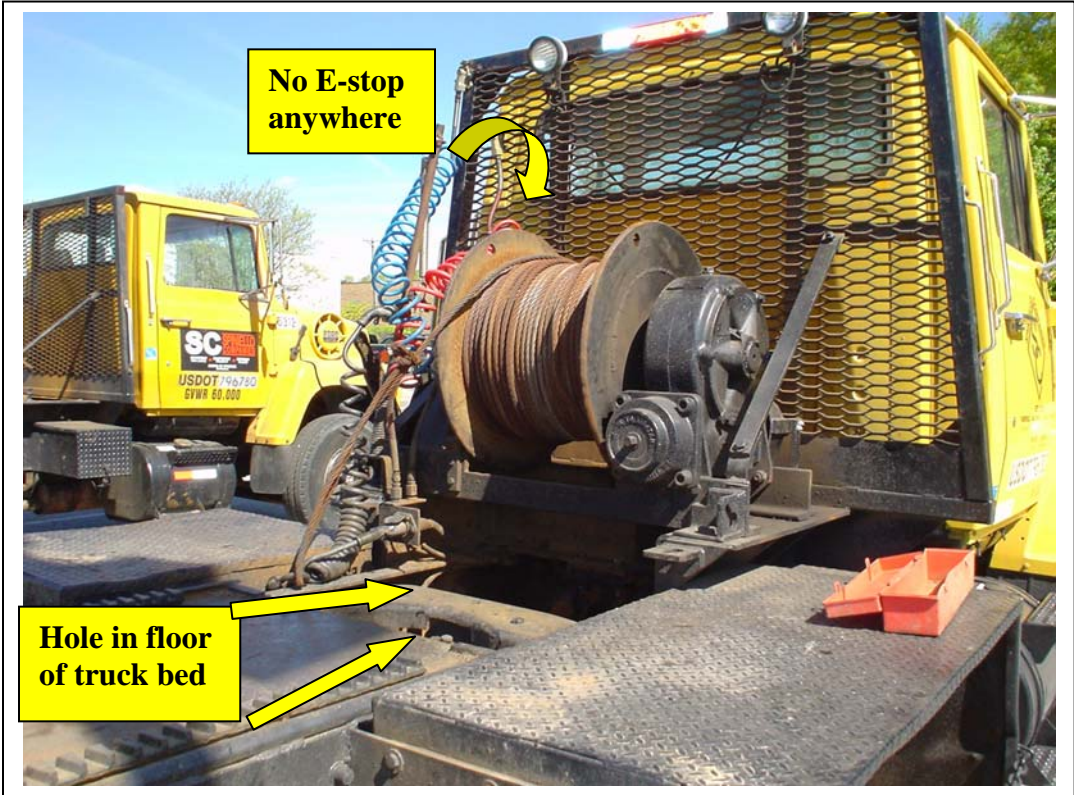
The winch is attached to a flat bed truck. It is used to pull steel cable through cast iron water pipes as part of a process to clean and re-line the pipe with cement. This process is used throughout the country. The truck and winch set-up or a similar set-up is also used extensively in many operations.

The major concern is the winch set-up. Even though many of the pipe re-lining companies have a policy that requires the operator to stay in the cab of the truck while the winch is running, the policy is a poor substitute for safety devices that are required for protection of workers from being wrapped up into the winch.

An emergency cable should be installed around the perimeter of the winch for emergency shut down. In addition, after inspection of three different company's equipment, it was found that the set-ups of this type equipment was lacking in all three companies. Not only is the E-stop cable not installed on any of the winches inspected, but there is also a hole in the floor plate directly in front of the winch where someone can stumble and fall into the winch.

Any company using this type of equipment should inspect and update the equipment with an E-stop and a floor plate should be installed directly in front of the winch.

- Any company using this type of equipment should inspect and update the equipment with an E-stop and a floor plate should be installed directly in front of the winch.
- Other devices such as a cable alignment device that guides the cable to wrap evenly on the drum should be installed.
